# REPEATED OBJECT RECONSTRUCTION OF THE BREMEN HANSE COG

M. Wiggenhagen, A. Elmhorst, U. Wißmann

Institute of Photogrammetry and GeoInformation (IPI), University of Hannover  
Nienburger Str. 1, D-30167 Hannover, Germany

### ABSTRACT:

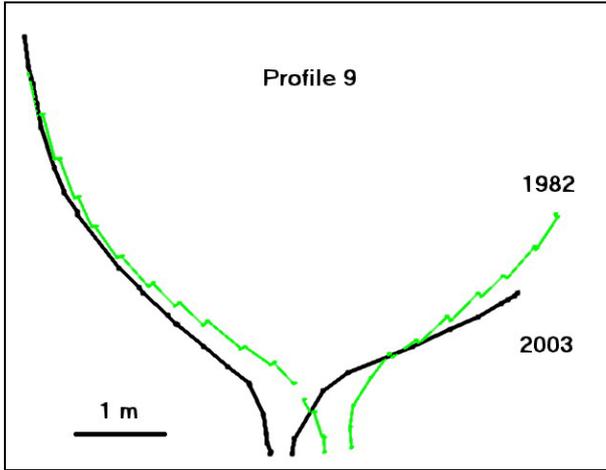
Figure 1. Distortions shown in profile 9

A comparison between the two measurements in 1982 and 2003 for profile 9 is shown in figure 1.

The following figure 2 shows one of the digital images with the location of the right part of profile 9. Between the roof of the museum hall and the cog several construction elements made of steel can be detected which allow the wood manufacturer to fix the cog in the desired location of the room. Some of these diagonals have been forced too much. Therefore the ship moved to the rotated location shown in figure 1.

The deformations of the cog are caused by several effects. Some local distortions are affected by the different expansion of wooden construction elements. Between horizontal planes and surface parts differences up to 20 cm could be detected. The main distortion of the whole ship was produced after the wood archeologists tried to repair local distortions with additional steel constructions inside the cog. The whole ship moved with its lower part to one side and rotated in one direction.

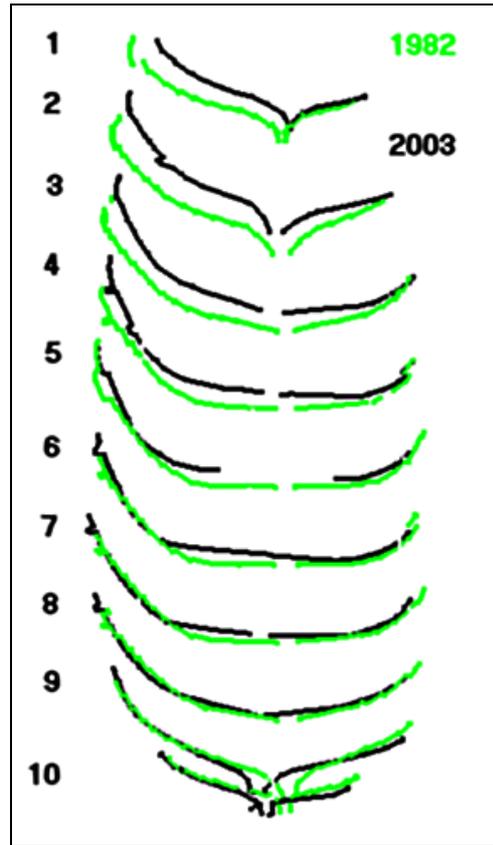
Figure 3. Comparison of profiles

This effect can be seen in an oblique visualisation of the cog from the front side to the back in figure 3.

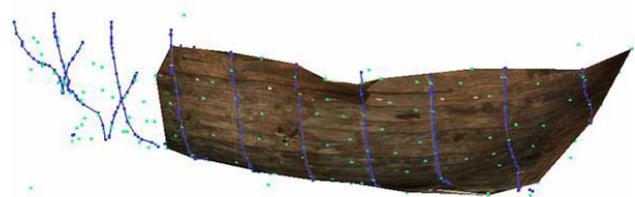
Figure 4. textured surface

For visualisation purposes the photo textures of some digital images were used to show the surface of the cog on top of the measured object point cloud. For the resampling of different locations 46 color images of the Nikon D100 were used. Apart of the left side of the cog was processed as a textured model.

An impression of the cog with some of the textured areas is shown in figure 4. The same textures were used for the processing of ortho images of the left side of the cog.

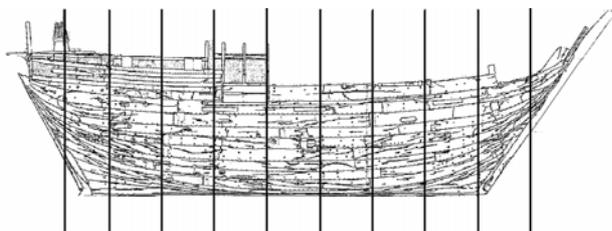
Figure 5. line drawing with profile lines

In comparison to the analogue imaging and photogrammetric measurement process the digital method requires many more images depending on the resolution of the digital cameras and the geometric conditions in the museum hall. In 1982 forty stereoscopic image pairs were necessary for the production of a line drawing of the wooden surface of the cog. For the measurement of the profiles only ten vertical lines had to be projected onto the surface from both sides of the cog (see fig. 5). Those lines were measured in stereo mode with the Stereoplanigraph C8 and were drawn in real time at a mechanical plotting table.

In 1982 line drawings and profile plottings in the scale 1:20 had been produced. The line drawings were produced for both sides of the cog and also for an inside view. The details shown in the drawings depend on the ability of the operator to do an interpretation of the image material and to select important features and draw them. As this was a very time consuming and expensive method today in most cases ortho image maps will be preferred.

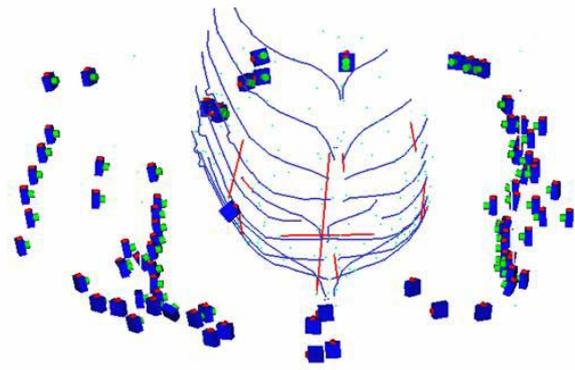
Figure 6. camera stations, profiles and control distances

In the second measuring campaign in 2003 over 99 images were necessary for the triangulation. 227 tie points and twenty signalled profile lines were required to offer enough points for the monoscopic measurement in the convergent images. The profiles exist of 340 measured points. The image coordinates of these points have been measured in manual mode with the pointing device of the PC. An overview of the camera stations, profiles, control distances and measured points is given in figure 6.

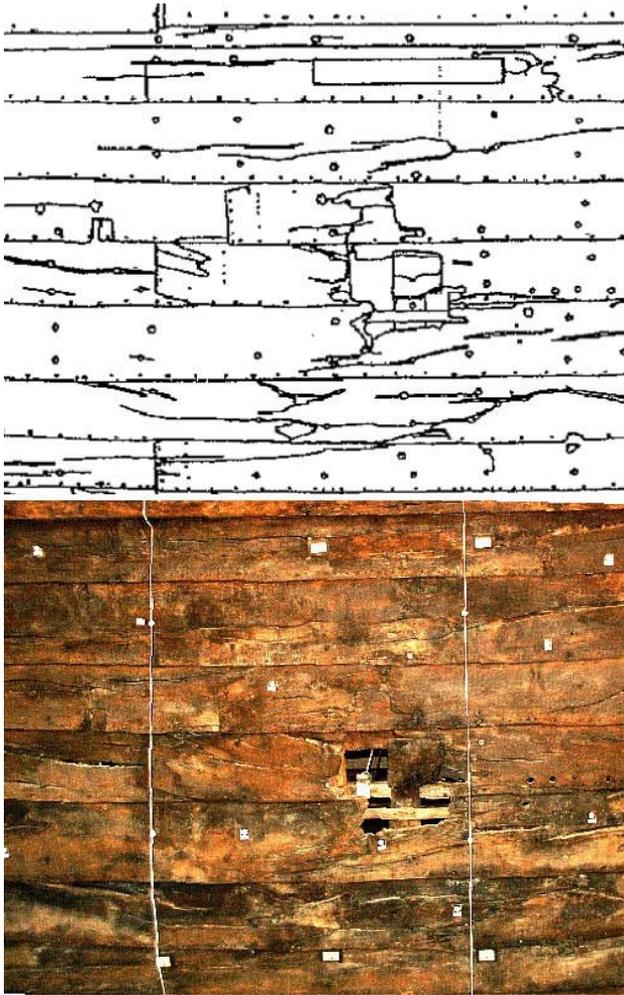
Figure 7. Comparison of line drawing and ortho image

For publication purposes additional three dimensional visualisations with textured surfaces and ortho images have been processed. One of the historical line drawings can be compared with a part of an ortho image in figure 7.
