***In Vivo* Degradation Behavior of the Magnesium Alloy LANd442 in Rabbit Tibiae**

Abstract: In former studies the magnesium alloy LAE442 showed promising *in vivo* degradation behavior and biocompatibility. However, reproducibility might be enhanced by replacement of the rare earth composition metal “E” by only a single rare earth element. Therefore, it was the aim of this study to examine whether the substitution of “E” by neodymium (“Nd”) had an influence on the *in vivo* degradation rate. LANd442 implants were inserted into rabbit tibiae and rabbits were euthanized after 4, 8, 13 and 26 weeks postoperatively. *In vivo* μ CT was performed to evaluate the *in vivo* implant degradation behaviour by calculation of implant volume, density true 3-D thickness and corrosion rates. Additionally, weight loss, type of corrosion and mechanical stability were appraised by SEM/EDS-analysis and three-point bending tests. Implant volume, density and true 3-D thickness decreased over time, whereas the variance of the maximum diameters within an implant as well as the corrosion rate and weight loss increased. SEM examination revealed mainly pitting corrosion after 26 weeks. The maximum bending

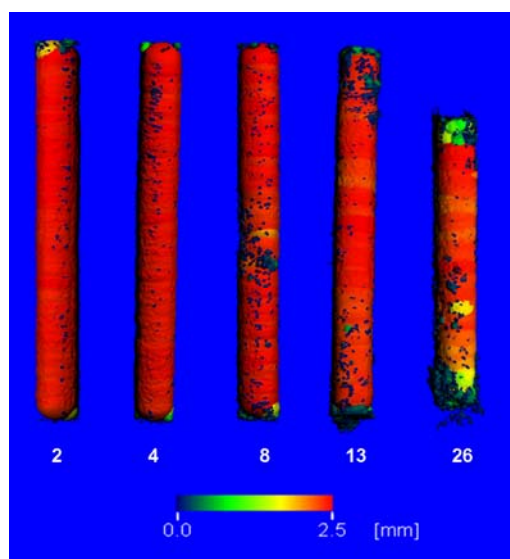
Figure 3. Images of the LANd442 implants' true 3D-thicknesses following different implantation durations in the rabbits' tibiae: from left to right: after 2 weeks, 4 weeks, 8 weeks, 13 weeks and after 26 weeks implantation periods. The colors correspond to the maximum diameters of the inserted balls; from red, yellow, green to blue, the diameter becomes smaller (red = 2.5 mm; blue = almost 0).

The mean 3D-thickness (Figure 3) did not change in the 4 weeks groups.

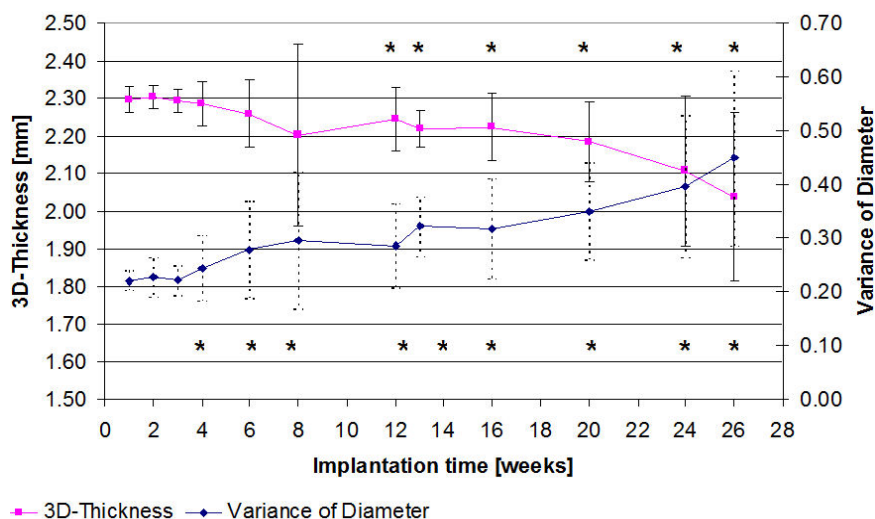
Figure 4. Representation of the 3D-thickness development and the variance of the implant's diameter determined by μ -computed tomography plotted over the course of 26 weeks. Significant changes ($p \leq 0.05$) compared to the second post implantation week are identified by a *.

The diameter's variance mainly increased continuously from the initial scan (Figure 4). Across all the time groups, it was possible to observe significant ($p = 0.032$) elevations from the 4th week in comparison to each of the initial scans. The mean diameter's variance was 195.7% of its initial value (0.23 to 0.45) after 26 weeks. It was possible to establish a significant difference ($p = 0.035$) between the final values of the 4 and 8 weeks groups but not between the 8 and 13 weeks or the 13 and 26 weeks groups. This was due to higher standard deviations.

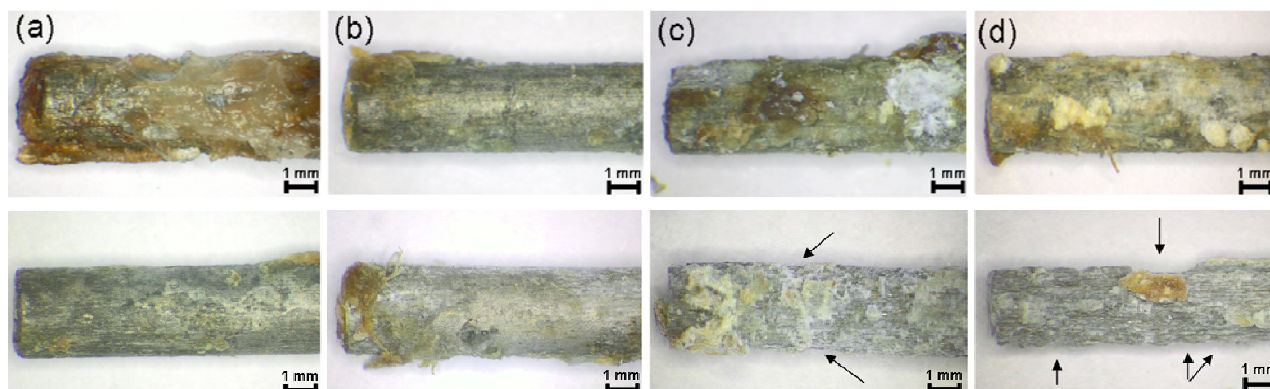
Figure 5. Stereomicroscopy images of explanted pins ($\times 2$ magnification): (a) 4 weeks; (b) 8 weeks; (c) 13 weeks; (d) 26 weeks; each prior to (top) and following (bottom) the hydrofluoric acid treatment: The arrows indicate the more severe corrosion.

Subsequent to explantation, it was possible to observe a brown-red mass on the implants, which almost covered the entire surface. In addition to this, white crystalline-like regions were found on the surface (Figure 5). These were most pronounced in the 13 and 26 weeks groups. All the pins exhibited an almost cylindrical shape after explantation. One implant from the 26 weeks groups exhibited eroded ends, significant corrosion pitting and a shorter length in comparison to the other implants from the same group.

After the treatment in hydrofluoric acid, bright silvery surfaces possessing longitudinal grooves were discernible on all the implants. These were least formed in the 4 weeks groups. The corrosion increased with increasing implantation duration. One implant from the 8 weeks groups showed a rounded end and was more severely corroded than the remaining implants after 8 weeks. However, this did not involve the implant which was radiologically more proximally situated in the tibia. The implants of the 13 weeks groups demonstrated, on average, a more severe corrosion than the implants in the 8 week group. It was possible to discern few, very shallow cavities after 13 weeks.

In comparison to the other groups, the implants in the 26 weeks groups demonstrated the most severe corrosion. They exhibited a rough and uneven surface possessing longitudinal grooves as well as the previously described white, crystalline regions. The implants' ends showed a tapered form and several shallow cavities on the surface (Figure 5(d) below).

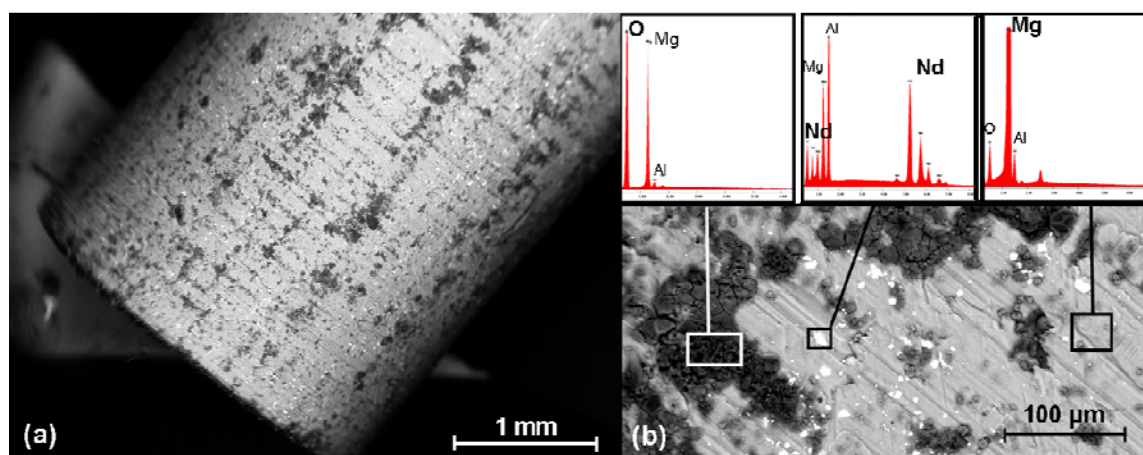
Figure 6. SEM images prior to implantation: (a) Overview of the pin's surface prior to the test; (b) EDX analysis of the pin's surface: preferentially detected Mg, Al, Nd and O. Each of the boxes mark the regions selected for the EDX analysis.

In the SEM, the pins showed a relatively smooth surface prior to implanting (Figure 6(a)), only the grooves due to manufacturing were discernible. In the EDX analysis, it was possible to identify oxygen and neodymium rich areas as well as magnesium and aluminium (Figure 6(b)).

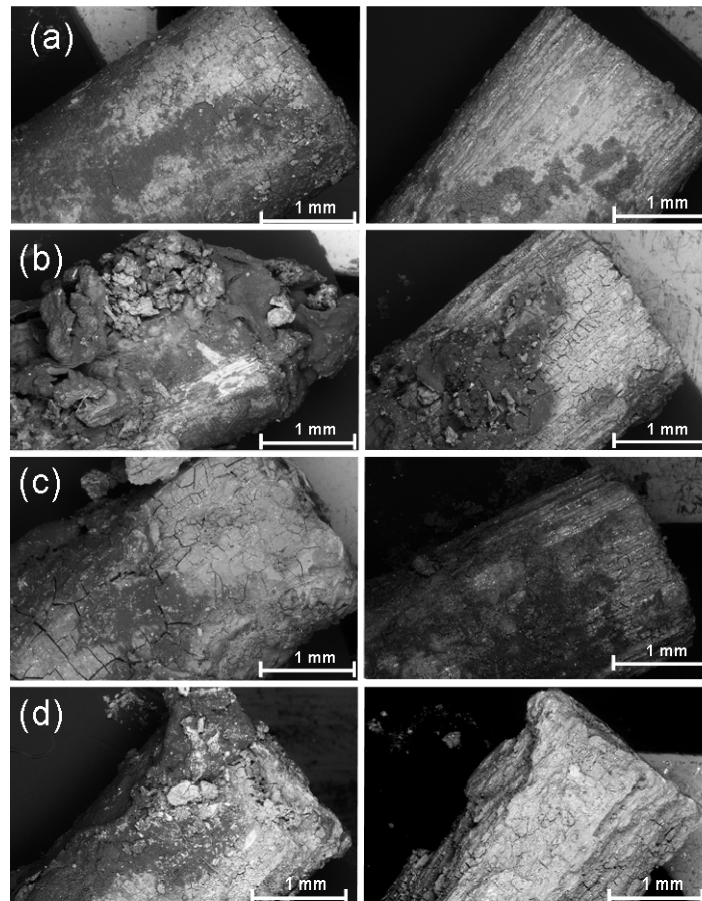
Figure 7. SEM images of the pin ends: (a) 4 weeks; (b) 8 weeks; (c) 13 weeks; (d) 26 weeks; each prior to (left) and following (right) hydrofluoric acid treatment

Following explantation, but prior to the hydrofluoric acid treatment, it was possible to observe an undulating and clump-like surface with cracks for all the implants (Figure 7, left column). In the EDX analysis, this surface contained above all magnesium, carbon, oxygen, phosphorus and calcium (Figure 8(a)). It was also possible to find small amounts of sodium, potassium and neodymium. In the

Following the hydrofluoric acid treatment (Figure 7, right column), implants from all the time groups exhibited different degrees of longitudinal grooves. In the 4 weeks groups, no changes in the cylindrical shape could be seen. In the 8 weeks groups, one implant exhibited eroded ends and an uneven surface. In this case, it involved the implant which was also noticeable in the stereomicroscope (however, not the implant which was radiologically more proximally situated in the tibia). The remaining implants retained their approximate cylindrical shape after 8 weeks as well as after 13 weeks. In the 26 weeks groups, two implants demonstrated eroded and jagged ends and corrosion pitting at several locations (Figure 7 (d) right column). It was possible to observe, particularly after 26 weeks, distinct grooves in the longitudinal direction, an uneven bumpy surface as well as clumps. In the EDX analysis, neodymium was partly found in the longitudinal grooves (Figure 9).

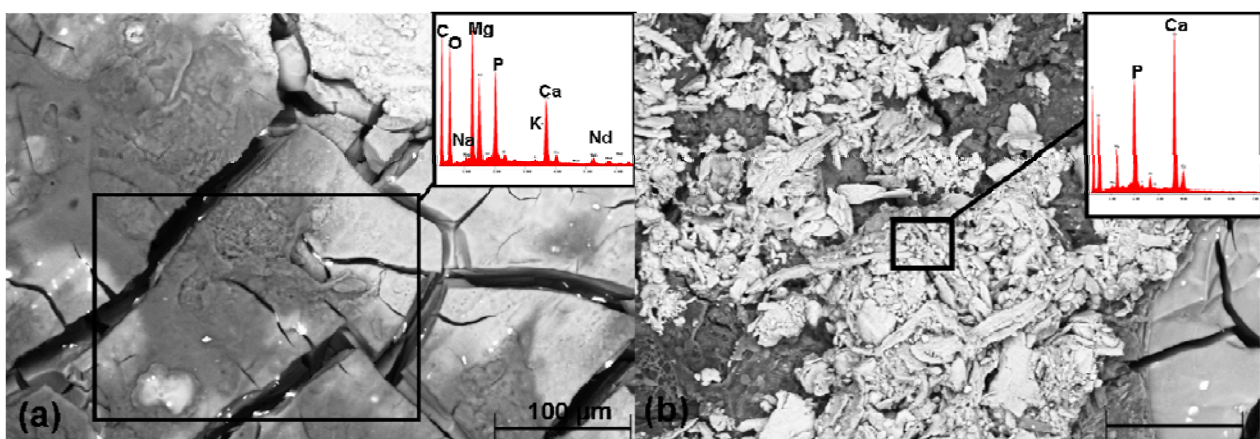
Figure 8. SEM images of the pin's surface using a pin following 26 weeks implantation prior to the hydrofluoric acid treatment and the EDX analysis of the individual elements in the marked regions: (a) clump-like structures; (b) crystalline structures, verification of Ca and P on the pin's surface. Each of the boxes mark the regions selected for the EDX analysis.

13 and, even more so, in the 26 weeks groups, it was possible to observe crystalline, brittle surface structures which exhibited high amounts of calcium and phosphorus (Figure 8(b)).

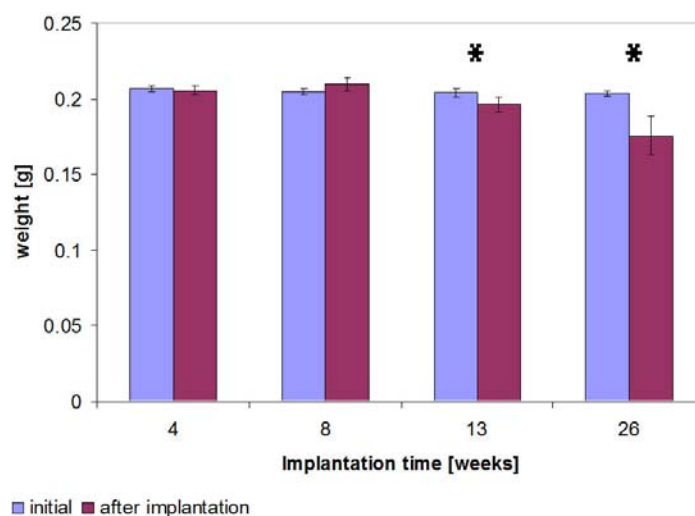
Figure 10. Implants' weight measurements following hydrofluoric acid treatment for the different implantation times 4, 8, 13 and 26 weeks, significant weight reductions ($p \leq 0.05$) in comparison to the initial values are verifiable from the 13th week and are identified by *.

Subsequent to explantation and to hydrofluoric acid treatment, the implants' weights for the 4 and 8 weeks groups were not significantly changed in comparison to the initial weight of 0.21 g (SD 0.002), but a slight weight gain after 8 weeks of 0.005 g could be found. In contrast to this, after 13 weeks the weight significantly ($p = 0.035$) reduced by 3.7% in comparison to the initial weight of 0.20 g (SD 0.005) and was significantly ($p = 0.01$) lower than the weight after eight weeks 0.21 g (SD 0.004). After 26 weeks, the weight loss in comparison to the initial weight increased by 13.7% (to 0.18 g (SD 0.013)) (Figure 10) and was thus significantly ($p = 0.05$) higher than that after 13 weeks.
