6th CIRP International Conference on High Performance Cutting, HPC2014

## Development and Analysis of Microstructures for the Transplantation of Thermally Sprayed Coatings

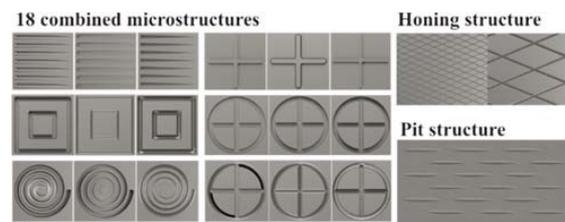
Figure 1: Developed microstructures

To demonstrate the limitations of the transplantation process, it is necessary to investigate different kinds of geometric aspects and corner shapes. Furthermore, it is important to determine where the maximum feasible structure ratio is settled by varying heights or depths and at which ratios the transplanting process is no longer possible while taking practical manufacturing aspects into account. To this end, eighteen microstructures, a negative honing structure and two different kinds of negative pit structures have been created (Figure 1). The eighteen microstructures comprise an array of grooves and small ridges which are made up of different geometric elements such as circles, spirals and linear elements. These microstructures are then tested with planar, round, and tapered groove bases. One of the small ridges is beveled at an angle of twenty degrees to ascertain whether it has a positive influence on the transplantation process. All eighteen structures have different aspect ratios and a maximum height or depth in the range of 100–400  $\mu\text{m}$ , with a surface size about 25  $\text{mm}^2$ . The negative honing structure is based on the surface produced by the original honing process and inverted for the transplantation process. The negative honing grooves have the form of tapered ridges with a height of 10  $\mu\text{m}$ , a honing-angle of 45°, and a center distance of 190  $\mu\text{m}$ . The negative pit structures, according to a direct structuring process which uses a rotating piezo-driven tool to create pit structures on rotatory workpieces [5]. They have a length of 2.4 mm and a width of 200  $\mu\text{m}$  with two different heights of 6  $\mu\text{m}$  and 30  $\mu\text{m}$ . These various height values are used to determine whether the oil retention volume can be regulated with structured transplanted surfaces. The last two structures are developed to show that even filigree microstructures measuring structure heights of roughly 10  $\mu\text{m}$  can be transplanted.

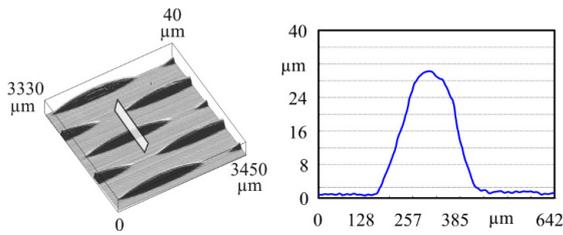
Figure 2: Sectioning through a pit of the negative pit structure with a maximum pit height of 30µm measured by a confocal microscope

During the micromilling process, it was possible to maintain tight tolerances. Despite the substantial kinematics of the machining center it was possible to create structures in a tolerance about  $\pm 2 \mu\text{m}$ . Particularly for the negative honing and pit structures, the machined surfaces demonstrated accurate form and shape tolerances. The direct comparison of the target measurements and geometry with the machined workpiece yielded a good correlation. Figure 2 shows a cross section through the middle of a pit from the negative pit structure with a maximum height of 30  $\mu\text{m}$ , measured with a confocal light microscope. The measurement shows that the milled structure

conforms tightly to the CAD geometry and has only a few deviations on the bottom of the pits.

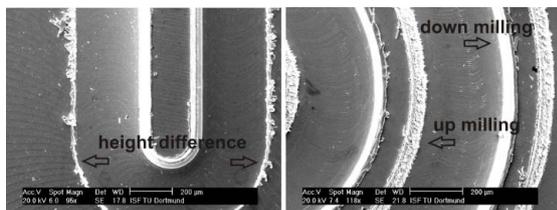
Figure 3: SEM picture of appeared structure defects

Defective surfaces or high shape deviations only occurred on the bottom of some structures. These resulted in part due to tool changes which were performed when necessary because of design constraints or tool wear. In those cases, where a tool change was performed, it was nearly impossible to perfectly match the heights, resulting in inadvertent burr formations on the bottom of some structures. The machining center was not equipped with a magnifying camera system so it was not possible to use a scratching test. Instead of using this test to minimize height differences resulting from tool changes while micromilling, tool changes should be avoided to reduce defective surfaces. When working with hardened materials, the end mill cutter demonstrates high wear in its corner areas which leads to defective cutting edges. Depending on the feed direction of the tool, different defects in the structures can arise. An example of these defects is shown in SEM pictures in Figure 3. On the base of the groove, the up milling and down milling sides show defective surfaces in the corner area. On the up milling side, the material looks shattered and rough while on the down milling side the material looks smeared and smudged.

Because the worn cutting edges of the end mill cause the material to be deformed and squeezed, it is not possible to guarantee good cutting operations. This leads to the typical ploughing effect which often occurs when the ratio of chip

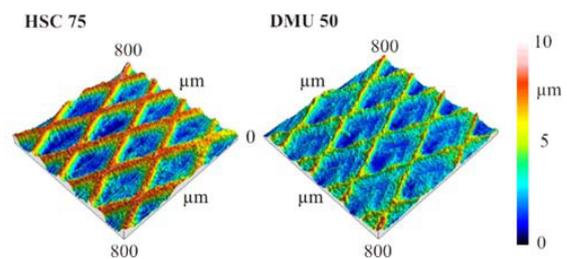
Figure 4: Comparison between different machining centers with a machined honing structure

thickness to the rounding of the cutting edges attains a high ratio [6]. To gauge how strong the influence of the machining center on the process could be, a direct comparison of different machining centers showed that the structure quality is dependent on the type of machining center used. The results of manufacturing the smallest structures on the DMG 50 EVO machining center were not of the same quality as those produced by the DMG HSC 75. The machined negative honing structure is not very smooth and shows a nearly shattered surface with ragged ridges. Furthermore, the height of the structure geometry of the ragged ridges fluctuates by about 5 µm (Figure 4). This is not only because the former machining center is an older series; the primary reason for this could be the use of different types of axle drives. Direct drive motors have less moving parts and therefore less mechanical clearance and deformation. The reversal range is lower and it is thus easier for the internal machine regulation to compensate for deviations in position [7].

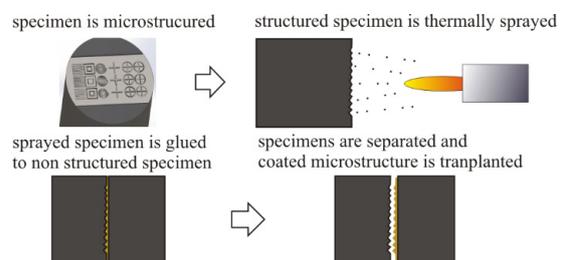
Figure 5: Schematic illustration of the simulation for the transplantation process

In a normal transplantation process for thermally sprayed coatings, the specimens are thermally sprayed, pressure cast, and subsequently separated by a tensile test machine. For a simulation of these, the pressure cast step is exchanged to a gluing process. Therefore the simulated transplantation process consists of the structured specimens being thermally sprayed by plasma spraying and glued on non-structured specimens. Afterwards, separation is achieved with a tensile test machine, as it would be in the normal, non-simulated process Figure 5.

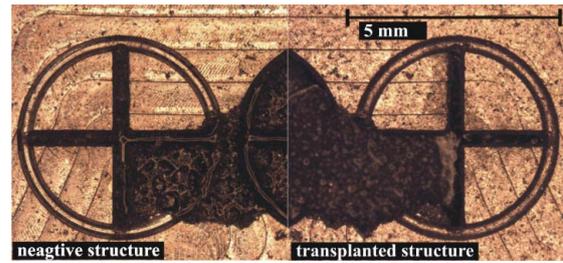
Figure 6: Comparison between negative structure and transplanted coating

The difference between ridges and grooves must also be considered. The use of grooves does not deliver the same result as using ridges. For example, the transplantation of ridges succeeded more often in the experiments performed and with higher aspect ratios than with grooves.

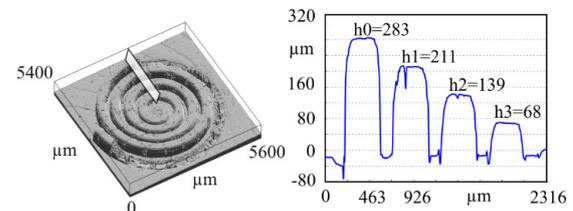
Figure 7: Transplanted spiral structure with a sectional view through the maximum reachable transplantation height.

One very important limitation for developing microstructures for coating transplantation is the aspect ratio of the geometry. In the experiments a width of 400  $\mu\text{m}$  is combined with different heights (ridges) or depths (grooves) to test different aspect ratios. The results show that it is possible to transplant coatings with a maximum height or depth around 300  $\mu\text{m}$  with an aspect ratio up to 0.75. A good example of this is shown in Figure 7 where a cross section shows the maximum attainable transplantation height. The figure shows that after reaching a structure depth of  $h_0 = 283 \mu\text{m}$  the transplantation of the coating was no longer reliable. These results were verified for various geometries and groove bases as well as for ridges and grooves. In some cases it was even possible to transplant aspect ratios up to 2, but it is nevertheless recommended to use structures with a lower aspect ratio in order to ensure a defect-free transplantation.

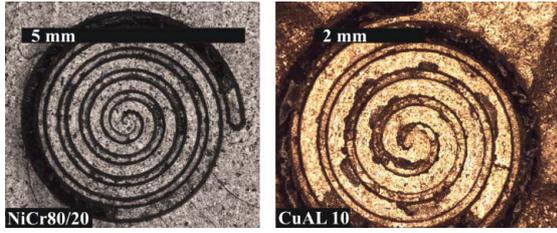
Figure 8: Comparison between NiCr 80/20 and CuAl 10 coating

In the experiments it was shown that it is possible to transplant microstructures with different forms, groove bases, and aspect ratios, with different coatings yielding different transplantation results. Figure 8 shows a direct comparison of two transplanted spiral microstructures by using different types of coatings. As is seen in the figure, the structures were not completely transplanted when using planar groove bases and an aspect ratio of 1. It was shown that the CuAL 10 coating, which has a middle size powder grain, is more prone to defects on the transplanted microstructures. For both planar groove bases and straight and sharp geometries, defective or non-transplanted areas could be found, especially in the corner areas of the flat groove bases (negative seen). Possible causes for

these defects could be the grain size or the lower adhesion of the coating. In addition, the transplantation showed that the complete breakaway of the structure occurs at a lower ratio than for the NiCr 80/20 coating. The NiCr 80/20 coating material possesses a much better surface quality and can be built up to much higher aspect ratios. Because of the small grain size of the NiCr 80/20 and its superior adhesive qualities, the whole structure is smoother and less porous.

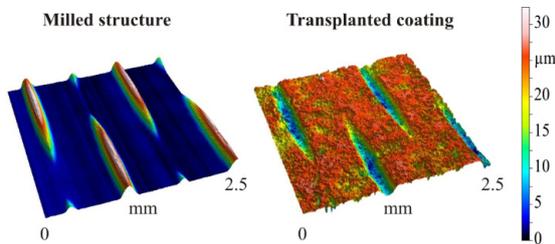
Figure 9: Comparison between milled pit structure (negative, 30µm) and transplanted coating

CuAl 10 coating, for example, the open cell character of the coating is such that the full shape of the 6 µm is not clearly discernible. In contrast to this is the behavior of the NiCr 80/20 coating which has better properties relating to the open cell character. As seen in Figure 9, the transplanted surface looks rougher than that of the milled structure; however, for a sprayed surface without any rework, the quality has good characteristics compared to a directly sprayed surface.

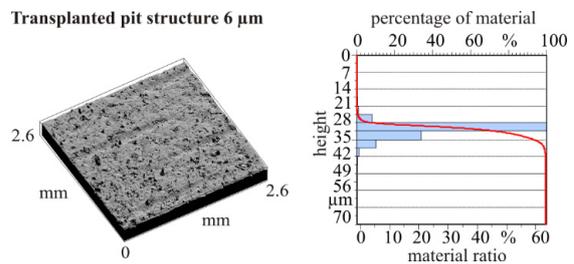
Figure 10: Confocal photo of the transplanted NiCr 80/20 pit structure 6 µm (left) with attendant material ratio curve (right).

Upon closer inspection of the bearing area curves in Figure 10 and Figure 11 it can be seen that it is possible to create surfaces with different characteristics. In Figure 10, the transplanted surface has a relatively high material ratio as well as a planar surface. Additionally, an oil retention of  $v_0 = 0.047 \text{ mm}^3/\text{cm}^2$  was reached, which is close to the calculated value of  $v_{cal} = 0.0469 \text{ mm}^3/\text{cm}^2$ . For good sliding properties, surfaces should show a sigmoidal curve and offer an oil retention capacity larger than  $v_{lit} = 0.02 \text{ mm}^3/\text{cm}^2$  [8]. Both of these attributes are present in the transplanted surface.

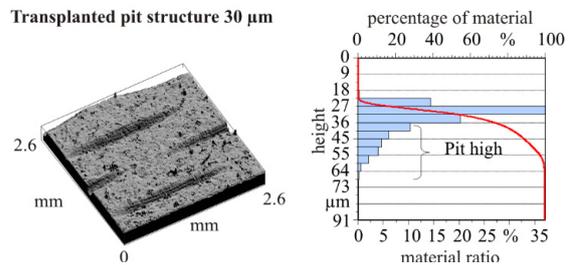
Figure 11: Confocal photo of the transplanted CuAl 10 pit structure 30 µm (left) with attendant material ratio curve (right).

The bearing area curve shown in Figure 11 does not reflect a surface as flat as in Figure 10. The reasons for this are twofold. One matter is the use of the CuAl 10 coating, which offers a rougher surface quality than NiCr 80/20. The second is the greater volume of the individual pits developed for this sample. Moreover, the surface also has a sigmoidal bearing area curve, but shows a significantly higher oil retention of  $v_0 = 0.167 \text{ mm}^3/\text{cm}^2$ , which is over three times larger than that of the surface with a 6 µm pit depth.

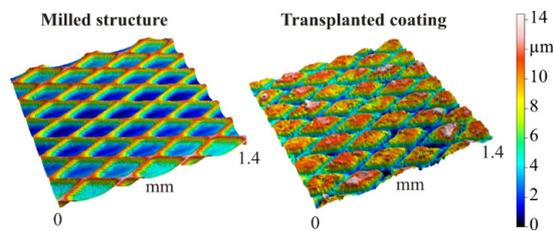
Figure 12: Comparison between milled honing structure (negative) and transplanted coating NiCr 80/20

The negative honing structure should show that it is even possible to transplant microstructures with very small geometrical features. In spite of its small dimensions, the structure itself has good transplantation characteristics, although the process was not equally successful for both coatings. It was not possible to transplant the structure with the CuAl 10 coating. When the open cell character is too large the appearance of these transplanted coatings was not suitable for its intended use. The NiCr 80/20 coating, on the other hand, yielded more favorable results. The transplanted surface is smoother, has less form and shape deviations, and no defective areas. In Figure 12 a comparison between a milled structure and a transplanted coating (NiCr 80/20) is shown. It can be seen that all necessary elements have been transplanted well. The coating fulfills its design requirements. It is obvious that the negative honing structure enabled even small and filigree structures with heights about 10  $\mu\text{m}$  to be transplanted. Furthermore it was possible to create a honing structure with specified geometric characteristics without using a honing process.
