# Performance of thermally modified timber (TMT) in outdoor application – durability, abrasion and optical appearance

### Original scientific paper · Izvorni znanstveni rad

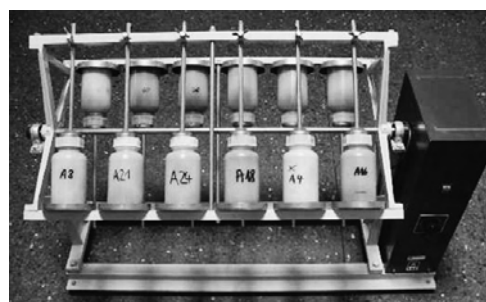
**Figure 2** Polyethylene flask, steel balls, specimens and over-head shaker used in Shaker-tests

The resistance to abrasion after the Shaker-method was determined as follows: 5 specimens of 35x10x10 mm<sup>3</sup> were oven dried, weighed and put into a polyethylene flask of 0.5 l together with 400 g of steel balls of 6 mm diameter (Figure 2). The filled flasks were put in an overhead shaker and rotated with 28 min<sup>-1</sup> for 72 hours. Afterwards, the specimens were cleansed of wood dust by air pressure, oven dried and weighed again to determine the abrasion in terms of mass loss. Five specimens were weighed together and gave one replicate, ten replicates were used.

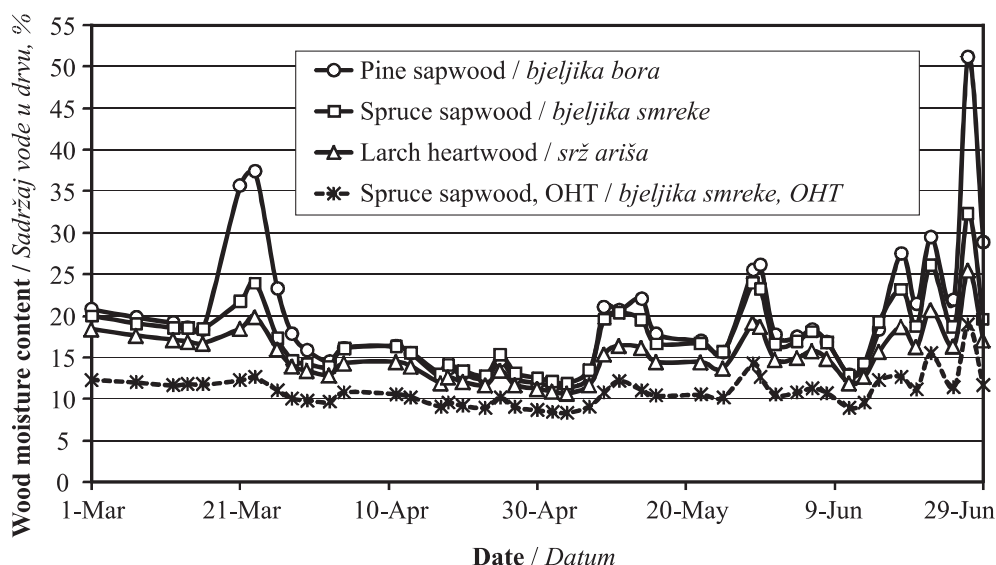
**Figure 3** Course of gravimetrically determined wood moisture content of façade boards in vertical exposure (Hamburg, 2007)

The gravimetric determination of MC of façade boards after 7 years in service showed, that the protective mechanism behind the increased durability of TMT, the reduced MC, was not changed by weathering impacts compared to its initial state (Figure 3).

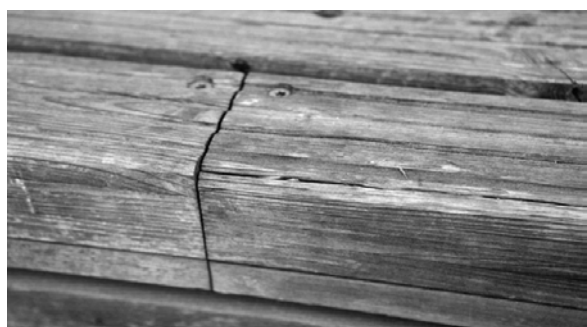
**Figure 7** Rounding of edges and break ups of TMT-gluelam in service

No remarkable formation of cracks by weathering or occurrence of flake offs was found, which points to the decreased dimensional changes of the façade due to reduced sorption of TMT. In contrast, the accessible TMT-gluelam apron showed substantial wear, caused by rounding of edges and break ups of the edges (Figure 7).

Here, the reduced mechanical strength (Bengtsson *et al*, 2002) and the decreased resistance to abra-

sion of TMT (Brischke *et al*, 2006) had a significant impact on the service ability in a heavy duty exposure.
